# Failure of Radial (Tainter) Gates Under Normal Operational Conditions

Best Practices in Dam and Levee Safety Risk Analysis

Chapter G-1

US Army Corps  
of Engineers®

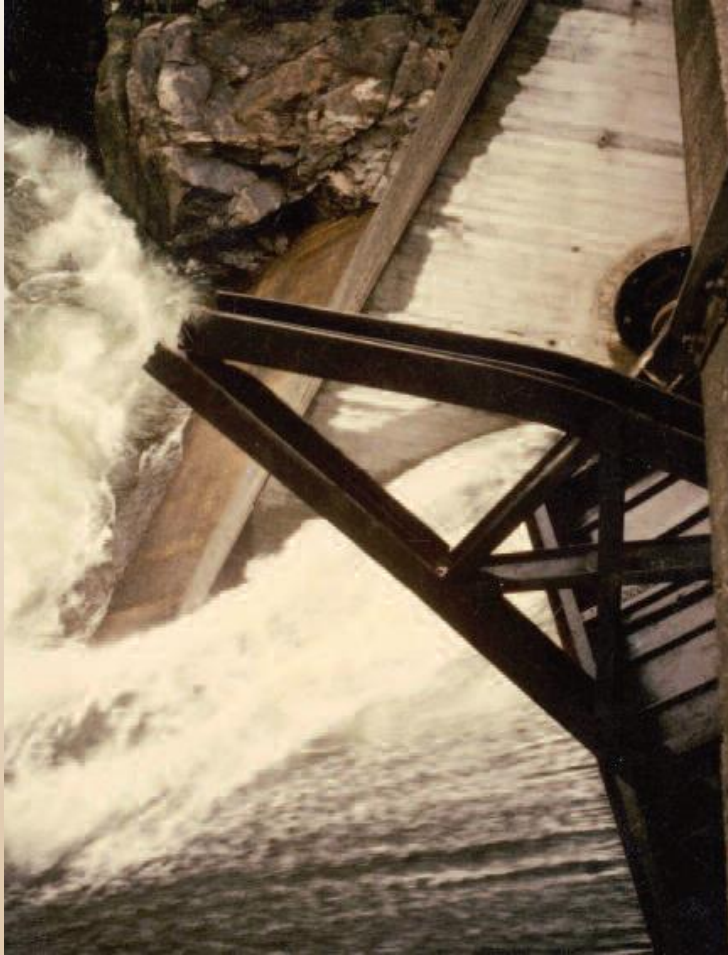
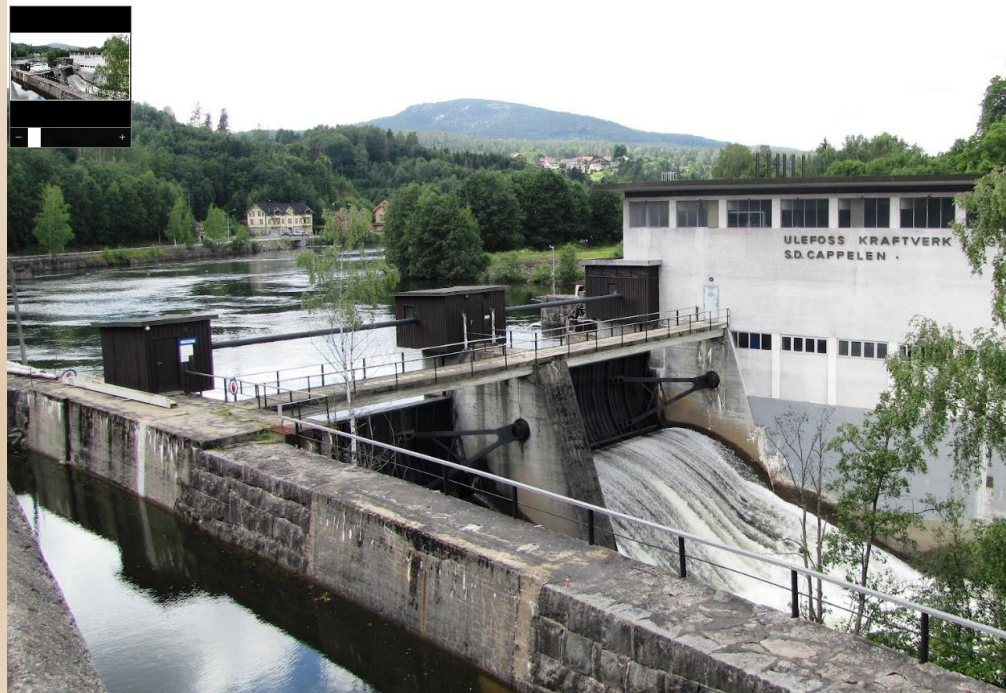
# Ulefoss Dam Gate No. 1 Failure (1984)

- Dam is located in Norway
- Failed during normal operation – cause attributed to trunnion friction
- Dam was constructed in 1961; Two radial gates
- 14.0 meters wide x 4.8 meters (46 x 16 ft); max. head 4.8 meters (16 ft)
- Trunnion pin dia. 300 mm/11.8 inches.
- Norconsult planned the repair works, including stop logs in running water, recovery of gate body, redesigning of bearings and gate arms.

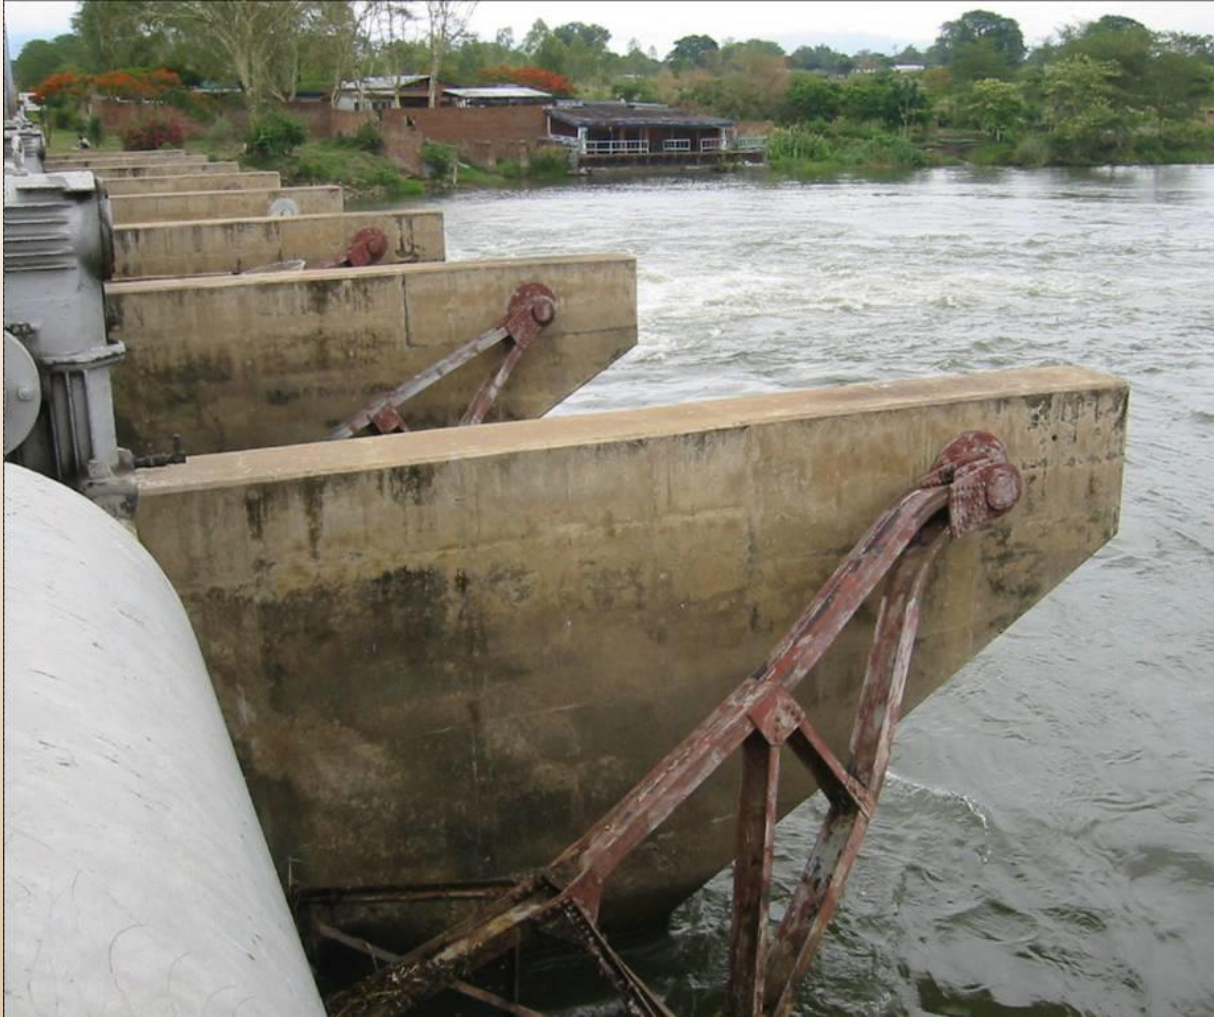
# Liwonde Barrage Tainter Gate Failure: Malawi, Africa

- Dam was constructed in 1965
- Maximum differential head of only 4 meters (13 feet)
- Small diameter trunnion pins
- Poorly maintained
- Date unknown when trunnion bearing seized and arm was bent.
- *Gate continues to be operated in severely damaged condition today.*
- A new dam with new gates is currently being constructed.

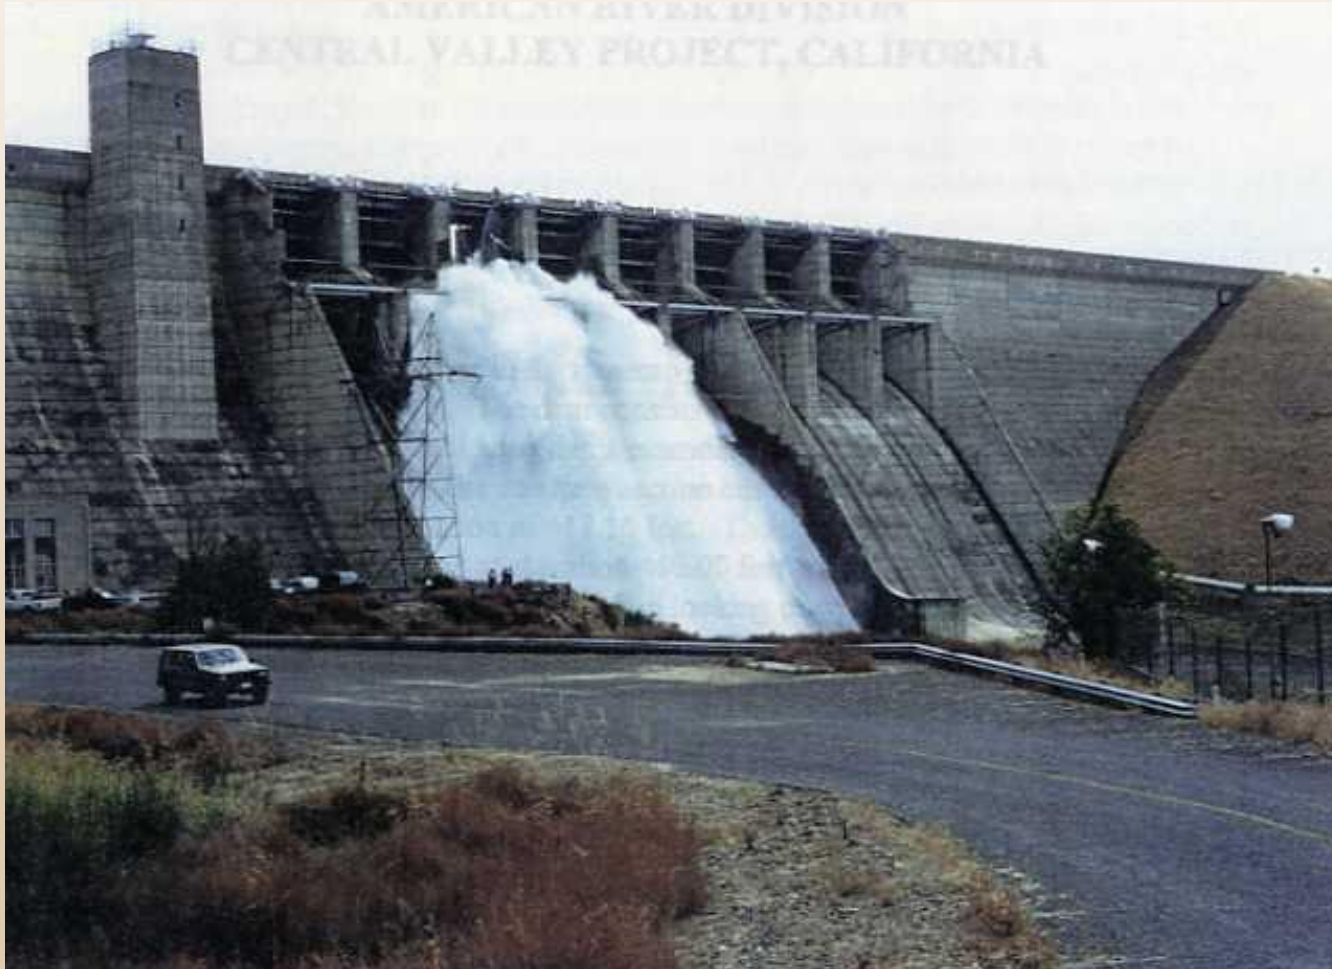
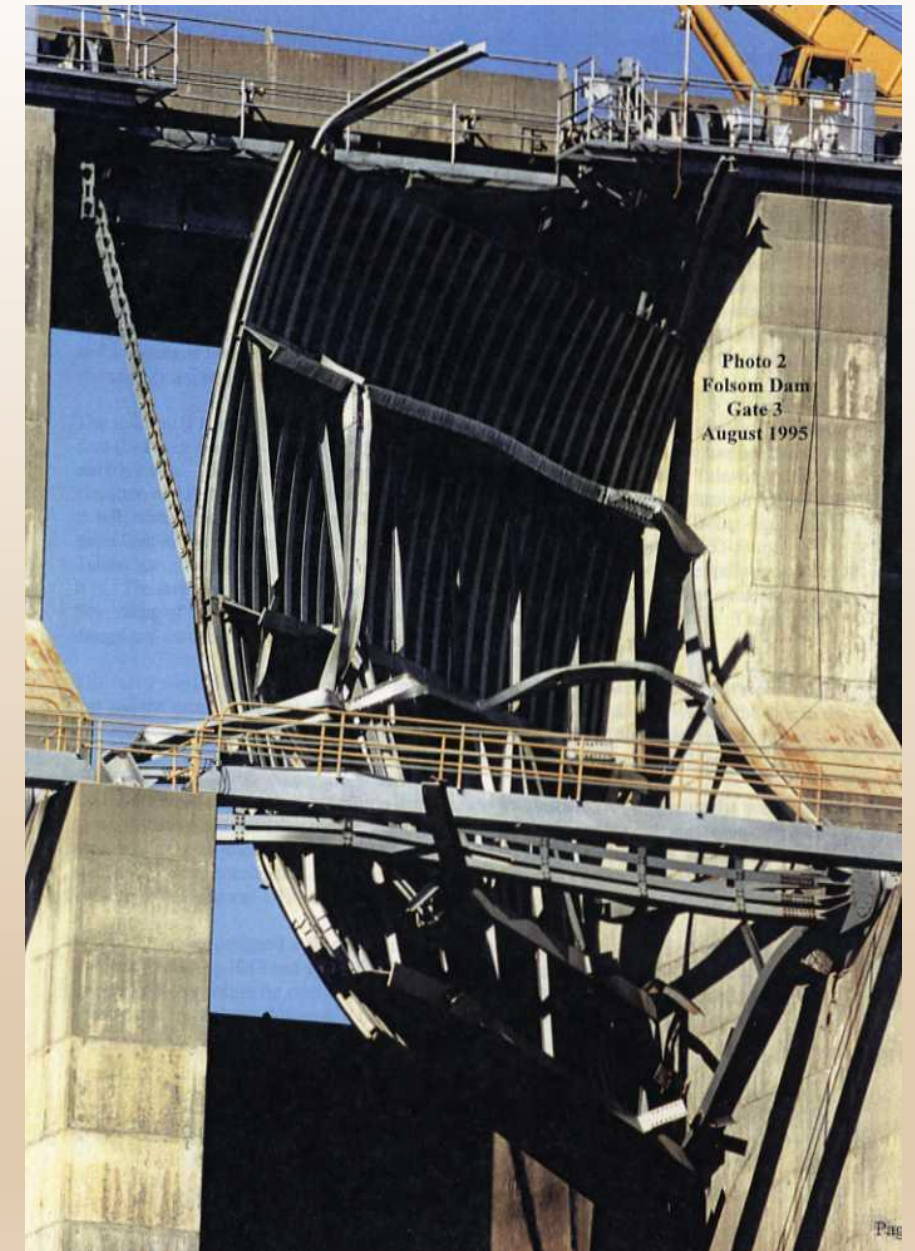
# Folsom Gate No. 3 Failure

- Spillway has eight spillway tainter gates (5 service, 3 emergency)
- Gate No. 3 failed suddenly on 7/17/95 with reservoir full
- Uncontrolled release peak – 40,000 ft<sup>3</sup>/s
- Failure started at lower strut brace, proceeded to adjacent braces and then arms buckled (determined to be trunnion pin friction)
- Contributing factors
  - Spillway gates weren't designed for trunnion friction loads
  - Large, hollow pin (32" diameter)
  - Reduced frequency of lubrication and lack of weather protection at ends of pin resulted in corrosion and increased friction over time
  - Struts 3 & 4 post failure evaluation led to conclusion about failure sequence

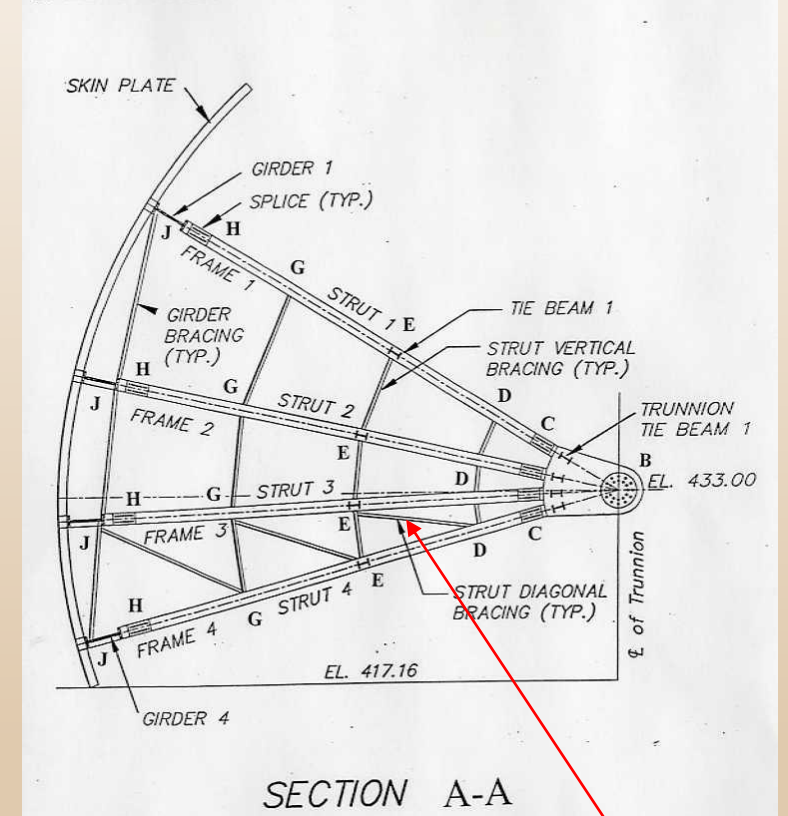
FORENSIC INVESTIGATION: IDENTIFICATION CODE FOR GATE CONNECTIONS

Initial Failure

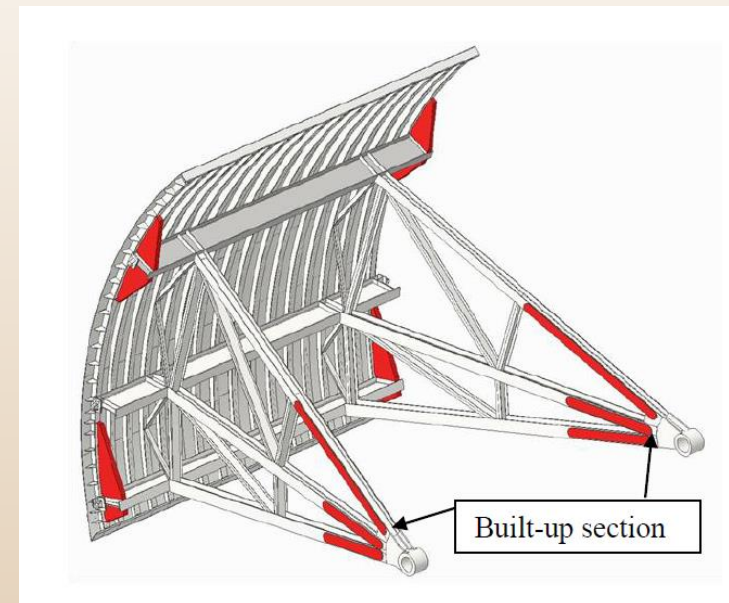
Strengthening (Red Highlights) of Fall Creek Dam Spillway Gates

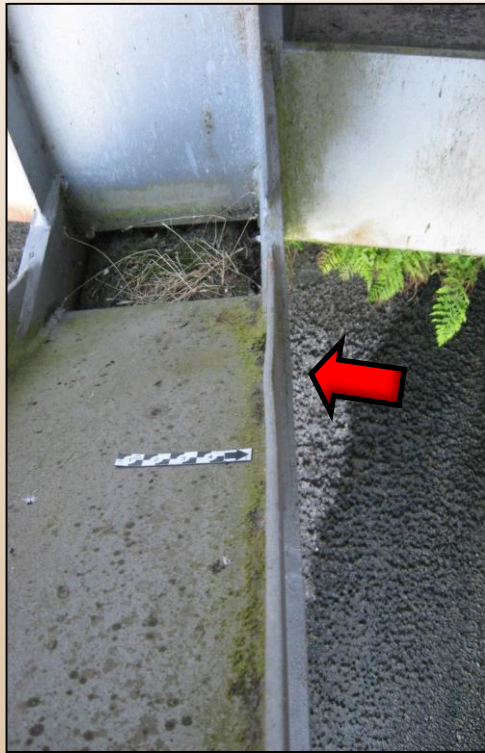
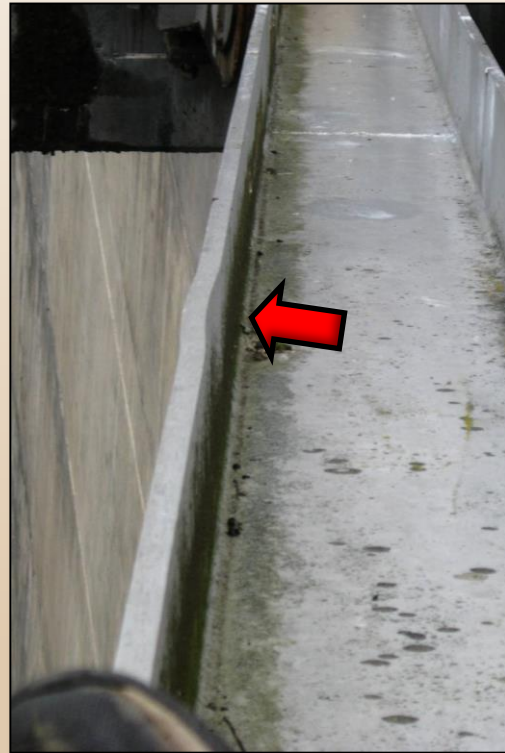
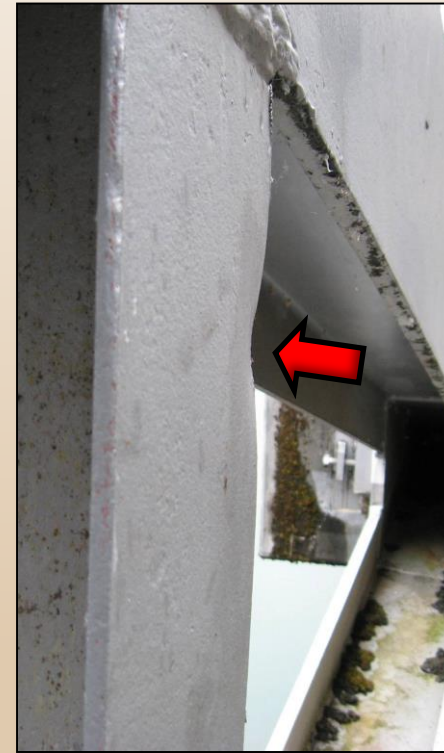
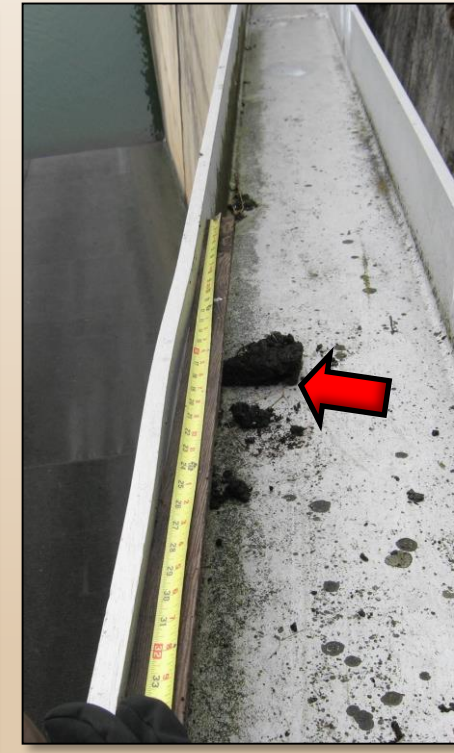
# Evidence of Buckling of Strut Arms at Foster Dam

- Top strut arms and diagonals showed signs of distress.

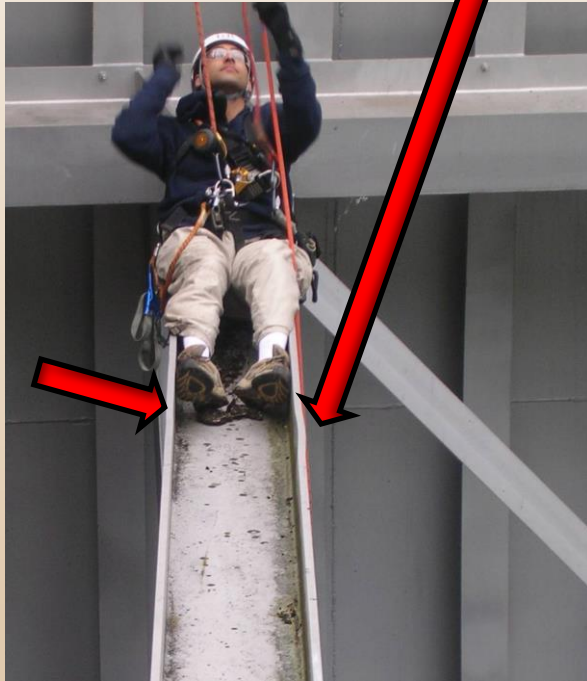
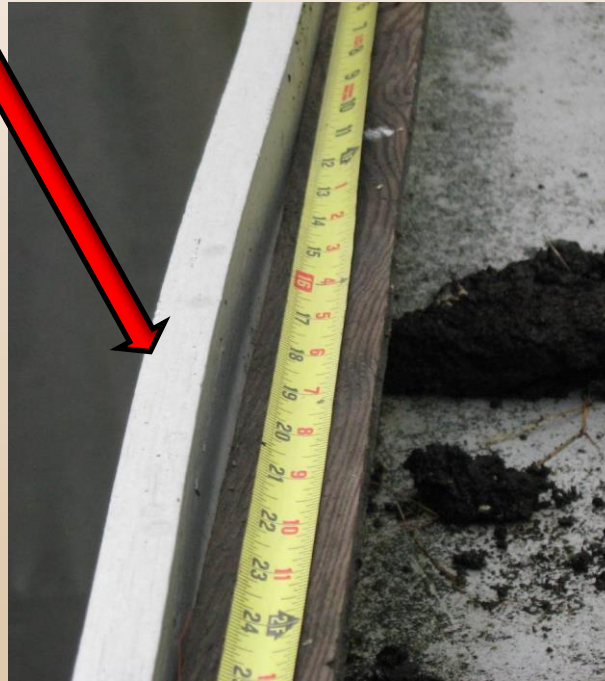
**Gates 1 & 2 in 2008: Deformation in North Top Strut; Twist, Bending, Buckling**

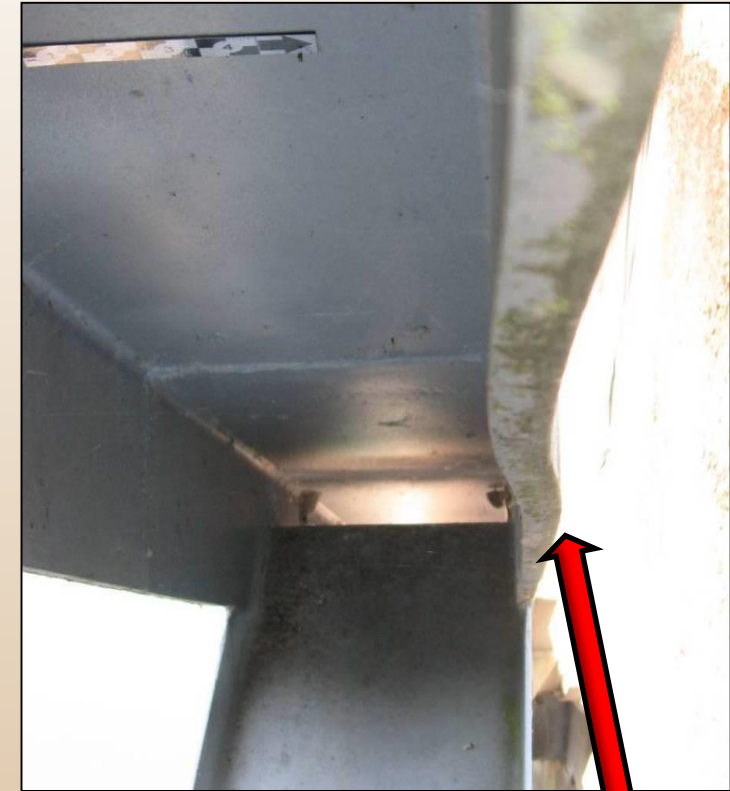
**Gate 3 in 2008:  
Deformation occurred  
after 2002 inspections**

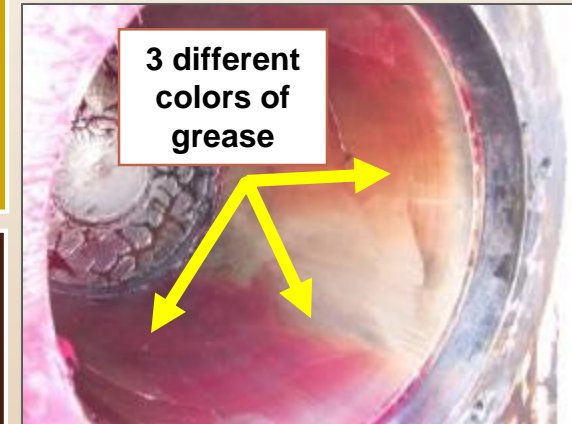
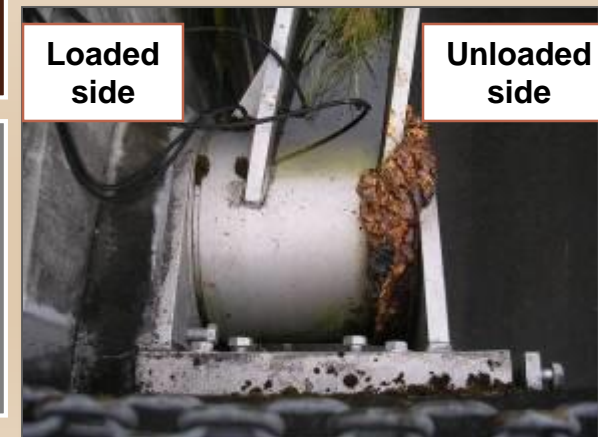
- Grease follows the path of least resistance.
- Gates should be operated through full range of motion annually.
- Different colors of grease show inadequate greasing (Pink = new; Tan = old)
- Inadequate greasing = excessive trunnion friction = additional moment forces.

- Original calculations ignore single-sided hoisting, skew, debris load, wave load.
- Original design used 0.2 as the coefficient of friction. New design criteria recommends 0.3.
- Thrust washer friction – does not receive grease

- Debris damage
- Gates have been operated at full pool for the last two years (powerhouse downtime prompted spill from Tainter gates).
- Deformations were load-induced

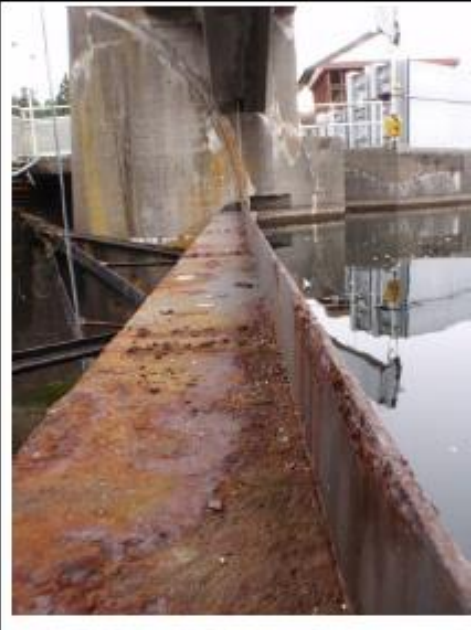
## Chittenden Locks Tainter Gates

- Dam was completed in 1916
- Gates are 32 feet wide and 8.5 feet wide; max. differential head -13 feet
- There are no emergency bulkhead slots and no emergency bulkheads.
- Gates underwent rehabilitation in 1944, 1953, 1977 and 1987
- Paint loss and extensive pitting of girders and channels.
- Rivet heads noted to have between 20-100% section loss.
- Gates at end of useful life in regard to safe/reliable operation

- The gates did not meet current criteria with regard to single sided hoisting operations, stall torque, trunnion friction, and/or impact.
- All gates replaced in 2014

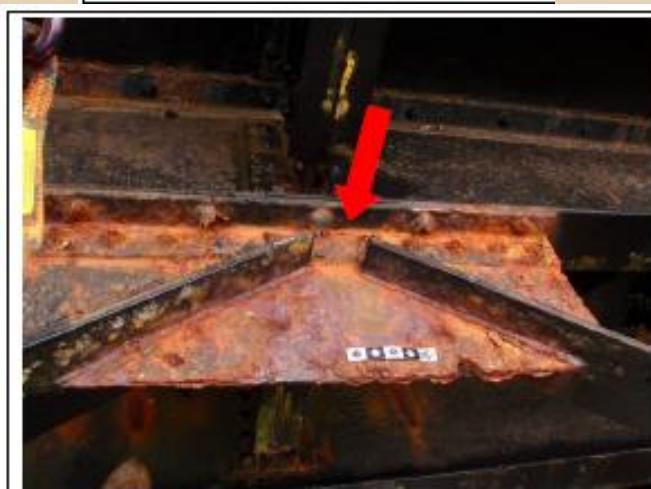
Photo 90: Gate 4 – Heavy corrosion of top horizontal center gusset plate. Up to 100% section loss on downstream edge of plate. Up to 100% section loss of rivets. Welded diagonal strut connections heavily corroded.

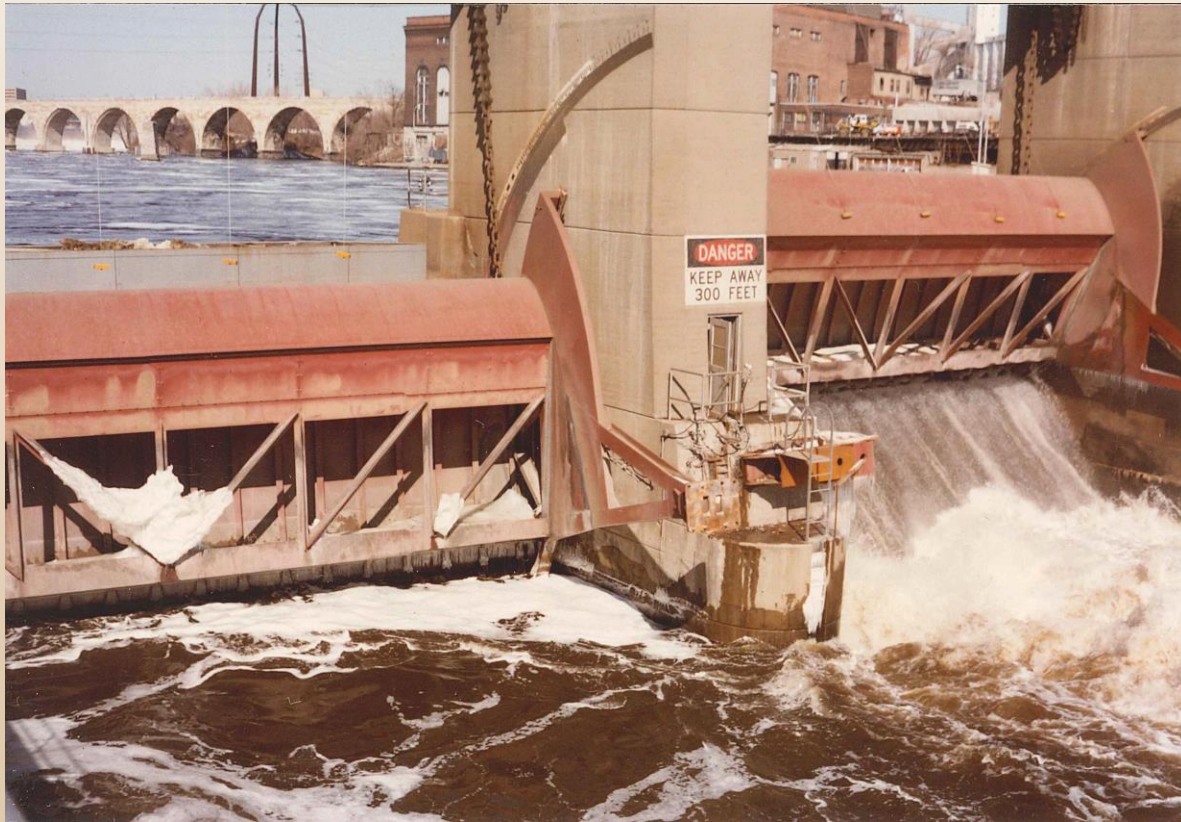
# Failure of Lower St. Anthony Falls Trunnion Girder Due to Ice Loading (1982)

- Dam was completed in 1956
- Gates are 56 feet wide and 15.2 feet wide
- Maximum differential head of 25 feet
- Well maintained
- Designed to pass ice/debris over gate crest
- ***Failed on 17 January 1982, at 1500. Temperature was +8°F; the previous night, temp was -20°F.***
- Considered a brittle failure; cracked welds and cracks in base metal subsequently discovered
- Original design did not allow for lateral ice load as now required by EM 1110-2-2702.
- 5,000 lb/ft. ice load would significantly overstress the trunnion girders
- Significant ice loads (>5' thick) have occurred

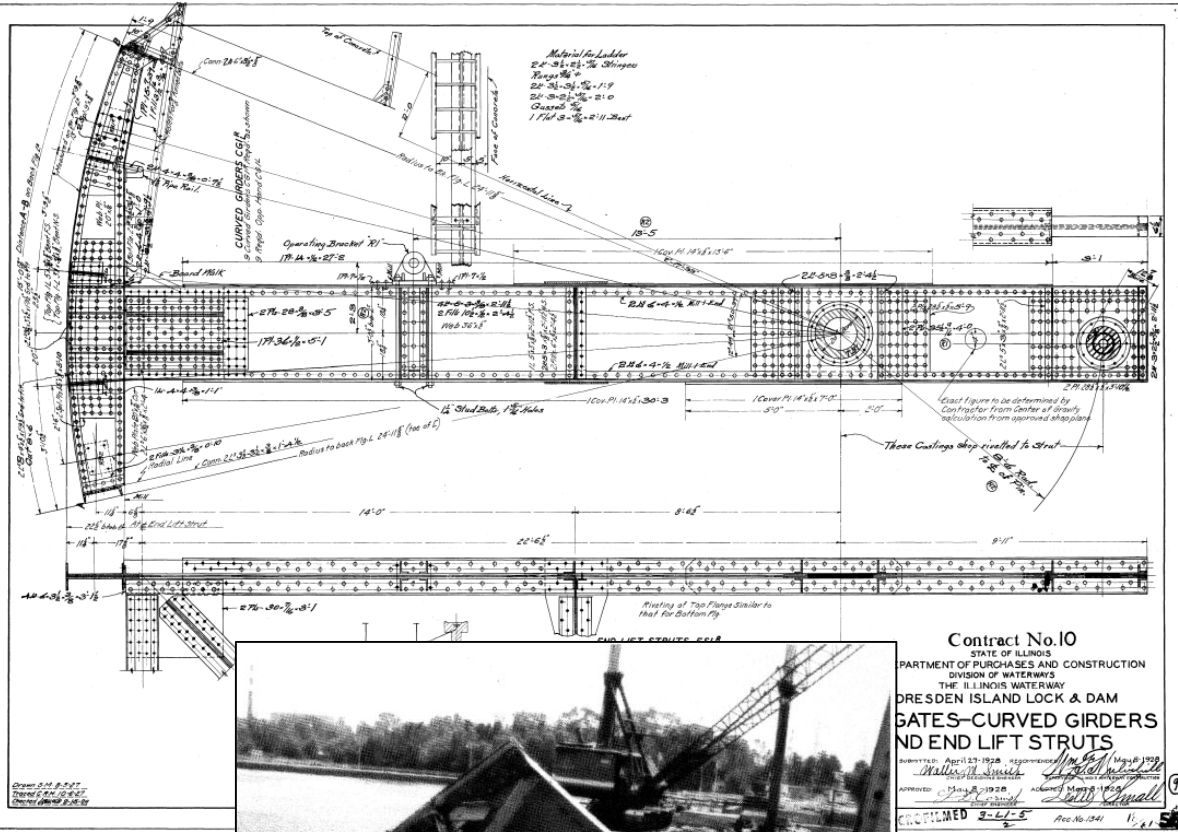
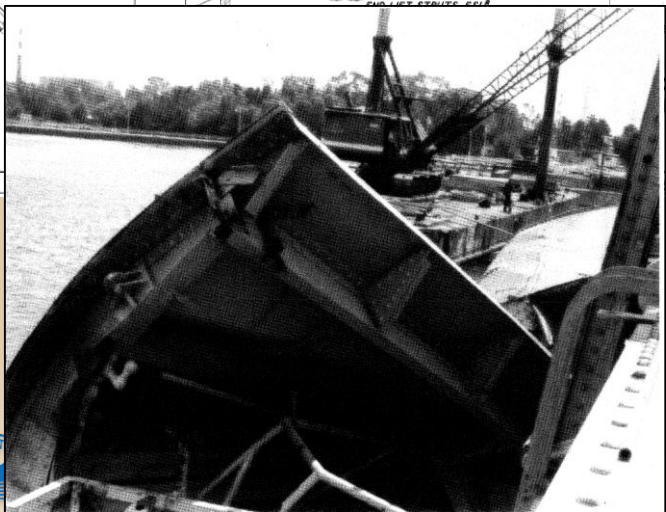
# Failure of Dresden Island Tainter Gates Due to Ice Loading (1982)

- Ice problems more numerous and severe in recent years as water quality has improved.
- Ice discharges from the Kankakee River, especially when ice jams break loose upstream, create difficulties in maintaining pool level as well as causing problems with ice at the tainter gates.
- Tainter gate electric motors do not have sufficient power to lift the gates when a mass of ice has accumulated on them.
- The gates are then operated manually using hand cranks or a heavy-duty electric drill.
- Hand chipping and steam are used to free ice from the gates.
- In March, 1982, Tainter gates No. 4 and 9 partially failed as a result of a buildup of floating ice and required replacement.
- Top cantilevered portions of these gates suffered ductile failure due to overload.

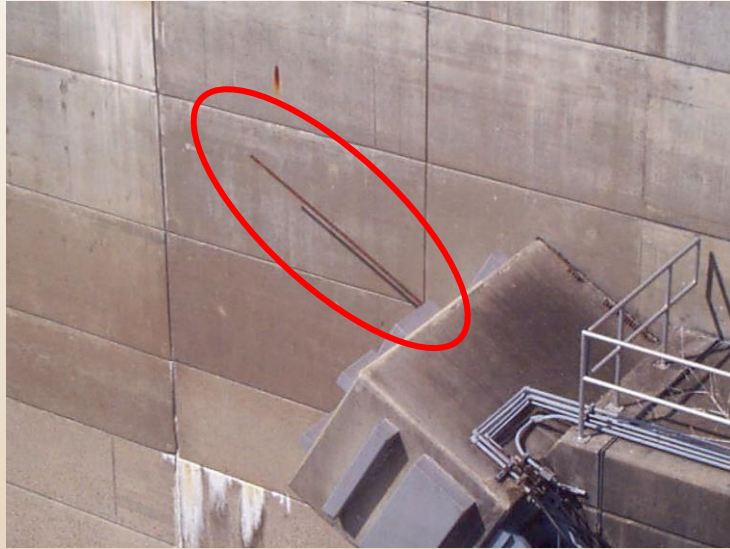
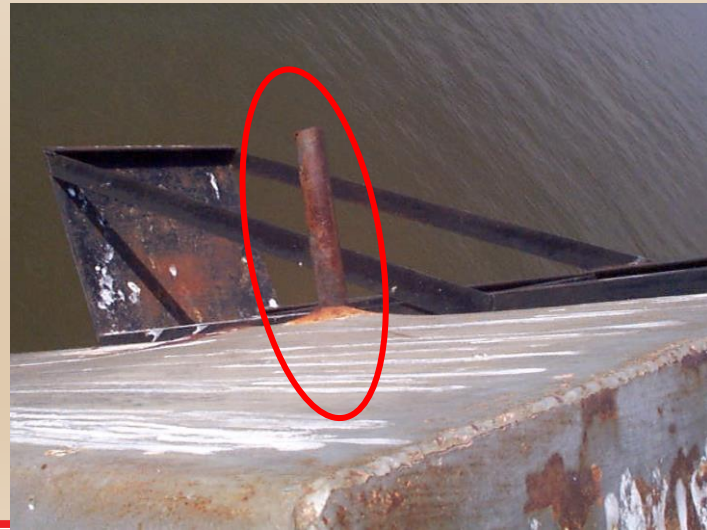
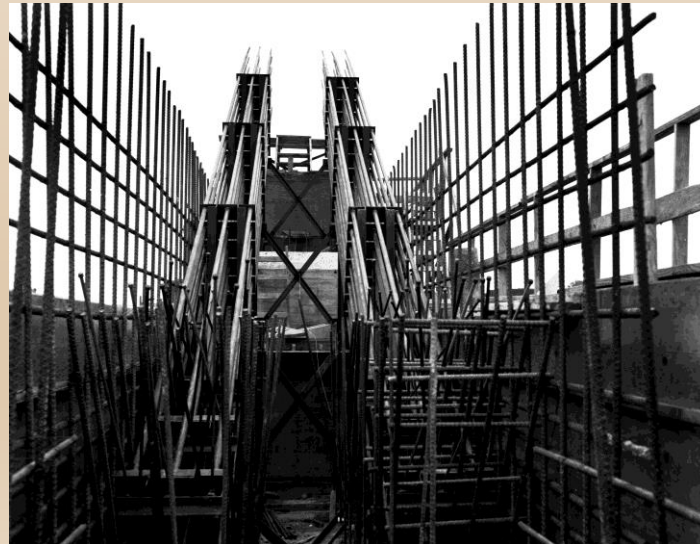
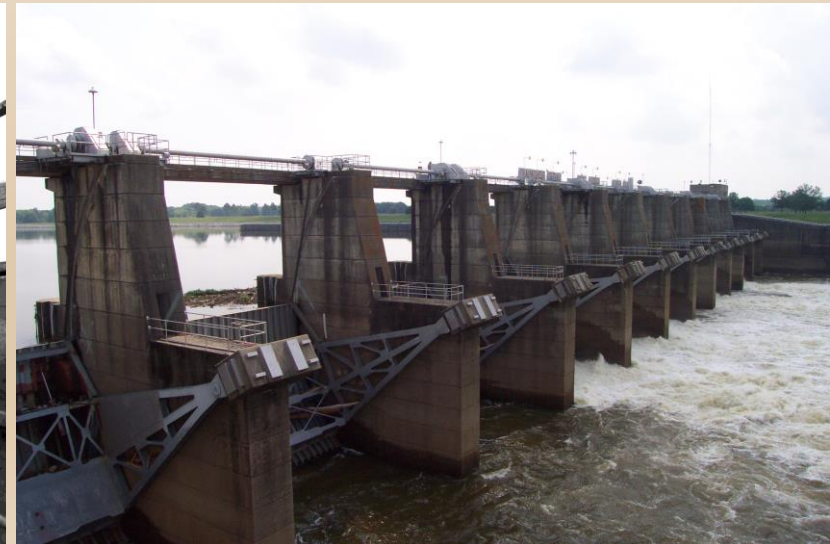
# Failure of Trunnion Anchorage Due to Corrosion

- R. F. Henry Dam (Mobile District) – construction completed in 1969
- 12 spillway piers containing 464 main trunnion girder anchor rods, each 1¼-inch diameter
- Radial gates are 50-ft wide by 31 ft tall
- As of November 2007, six anchors failed; one each in piers 1 (in 2006) and 3 (in 1969) and two each in piers 2 (in 1972) and 9 (in 2006).
- Specified rods were brittle. Also 100% loss of grease had occurred.
- Factor of Safety of 1.0 with loss of four rods per pier
- If there is loss of 3 rods, gate will be closed, stoplogs placed
